**NASA
Technical
Paper
2380**

Full-Scale Crash-Test
Evaluation of Two Load-
Limiting Subfloors for
General Aviation Airframes

Huey D. Carden

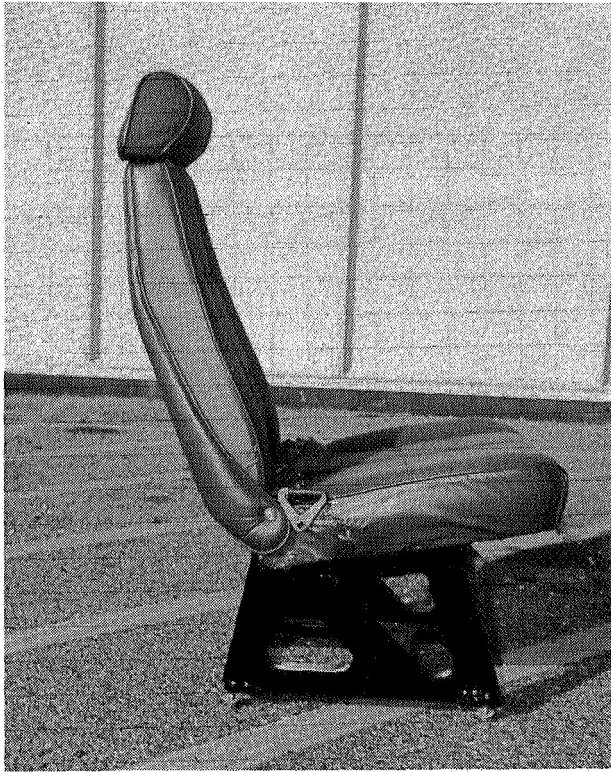
L-82-11,117
(a) Standard seat (first and third passengers).

L-82-11,118
(b) Load-limiting seat with S-shaped legs (pilot).

L-82-11,114
(c) Wire-bending load-limiting seat (fourth passenger).

L-82-9980
(d) Composite-tube load-limiting seat (second passenger).

Figure 11. Seat types used in airplane test series.

Figure 10 illustrates the arrangement of the occupants and restraints for each test, and the restraints are also visible in figure 11. All lap belts and shoulder harnesses (except for the pilot's) were secured to the seats. The pilot was restrained with a lap belt attached to the seat and with a double shoulder harness attached

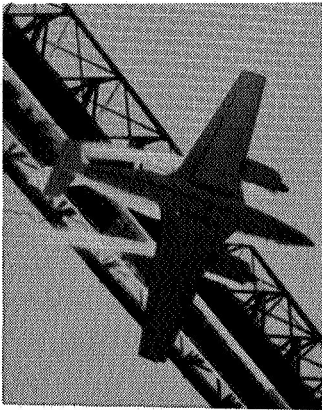
L-83-5249

Figure 13. Typical crash sequence of test airplane (unspecified time intervals).

Figure 13 presents a series of photographs illustrating the crash sequence typical of the three tests in the investigation of load-limiting structural concepts. The sequence, from top to bottom in rows left to right at unspecified time intervals, begins shortly after release of the airplane from the pullback position. The rocket plumes are readily visible in the photographs. The last five photographs in the sequence show the airplane approaching the impact surface in the flat, or belly-landing, attitude used to test the load-limiting subfloors. Areas damaged during the crash are not readily observable in the sequences because the major structural damage was confined to the underside of the airplane for the -15° flight path and the 0° pitch impact attitude.
